**GSA RECLAMATION YARD, SWMU NO. 010  
SOUTHWEST HOT SPOT INTERIM MEASURE  
PERFORMANCE MONITORING REPORT  
KENNEDY SPACE CENTER, FLORIDA**

**National Aeronautics and Space Administration  
Kennedy Space Center, Florida**

**December 2015  
Revision 0**

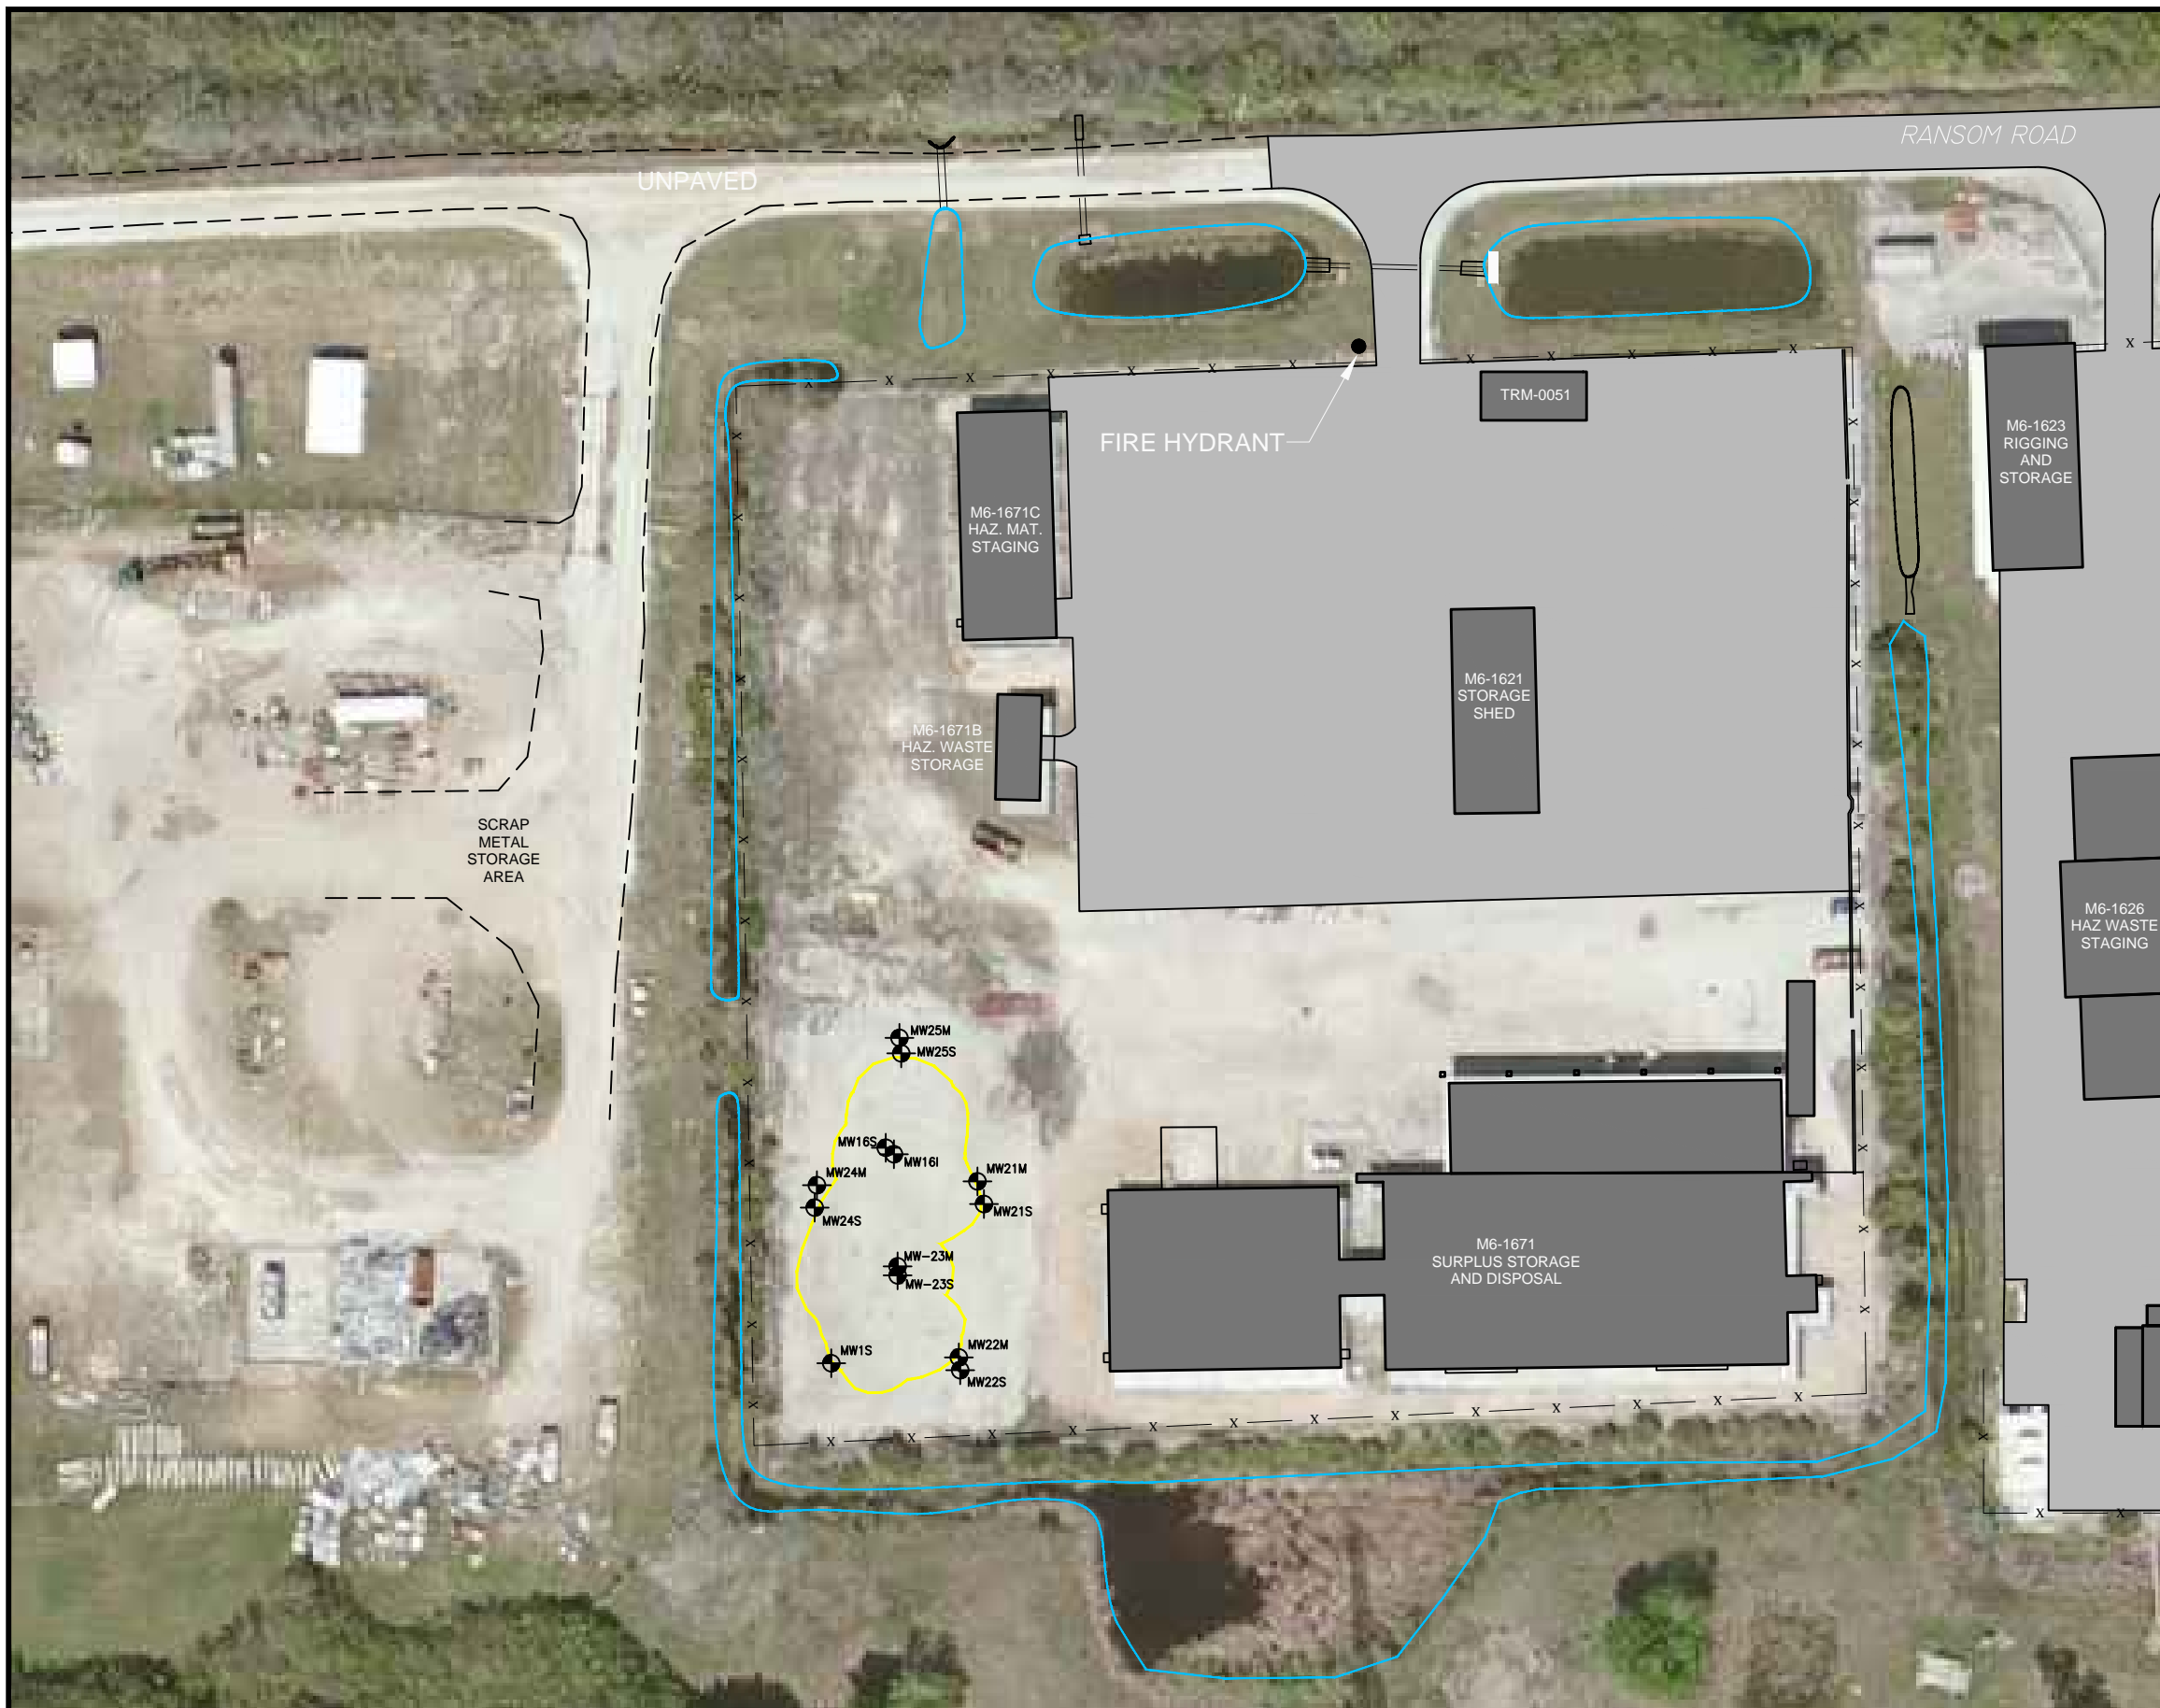
GSA Reclamation Yard  
Southwest Hot Spot Interim Measure  
Site Layout

The site name, GSA Reclamation Yard, or GSRY, is a carryover from the time environmental investigations began. The facility is currently operated by KSC's Institutional Support Contractor and is called the Reutilization, Recycling and Marketing Facility. The main part of the site, which is also where this recent IM was implemented, is a fenced compound housing several buildings and the equipment storage/display yard. The largest structure in the Reclamation Yard is the Surplus Storage and Disposal Building (Facility M6-1671), which sits near the south fenceline. Personnel occupy this facility throughout the work day. Near the center of the yard is a storage shed (M6-1621), which is not routinely occupied. The same is true of the Hazardous Waste Staging Shelter (M6-1671B) and the Hazardous Material Staging Building (M6-1671C). The northeast portion of the yard is paved with asphalt; the remainder has a gravel finish or – along the western fenceline – is bare earth. A security fence encloses the GSA Reclamation Yard, which is locked after duty hours. The single entrance to the GSA Reclamation Yard is from Ransom Road. Ransom Road borders the site to the north, with retention ponds on either side of the entrance. A drainage ditch encircles the other three sides of the site, merging into a normally dry stormwater retention feature at the northeast. To the east of the site is KSC's Corrosion Control Facility. To the west is the Reclamation Facility's scrap storage yard. The south is bounded by undeveloped land. Figure 1-2 provides an overview of the site and surrounding features.

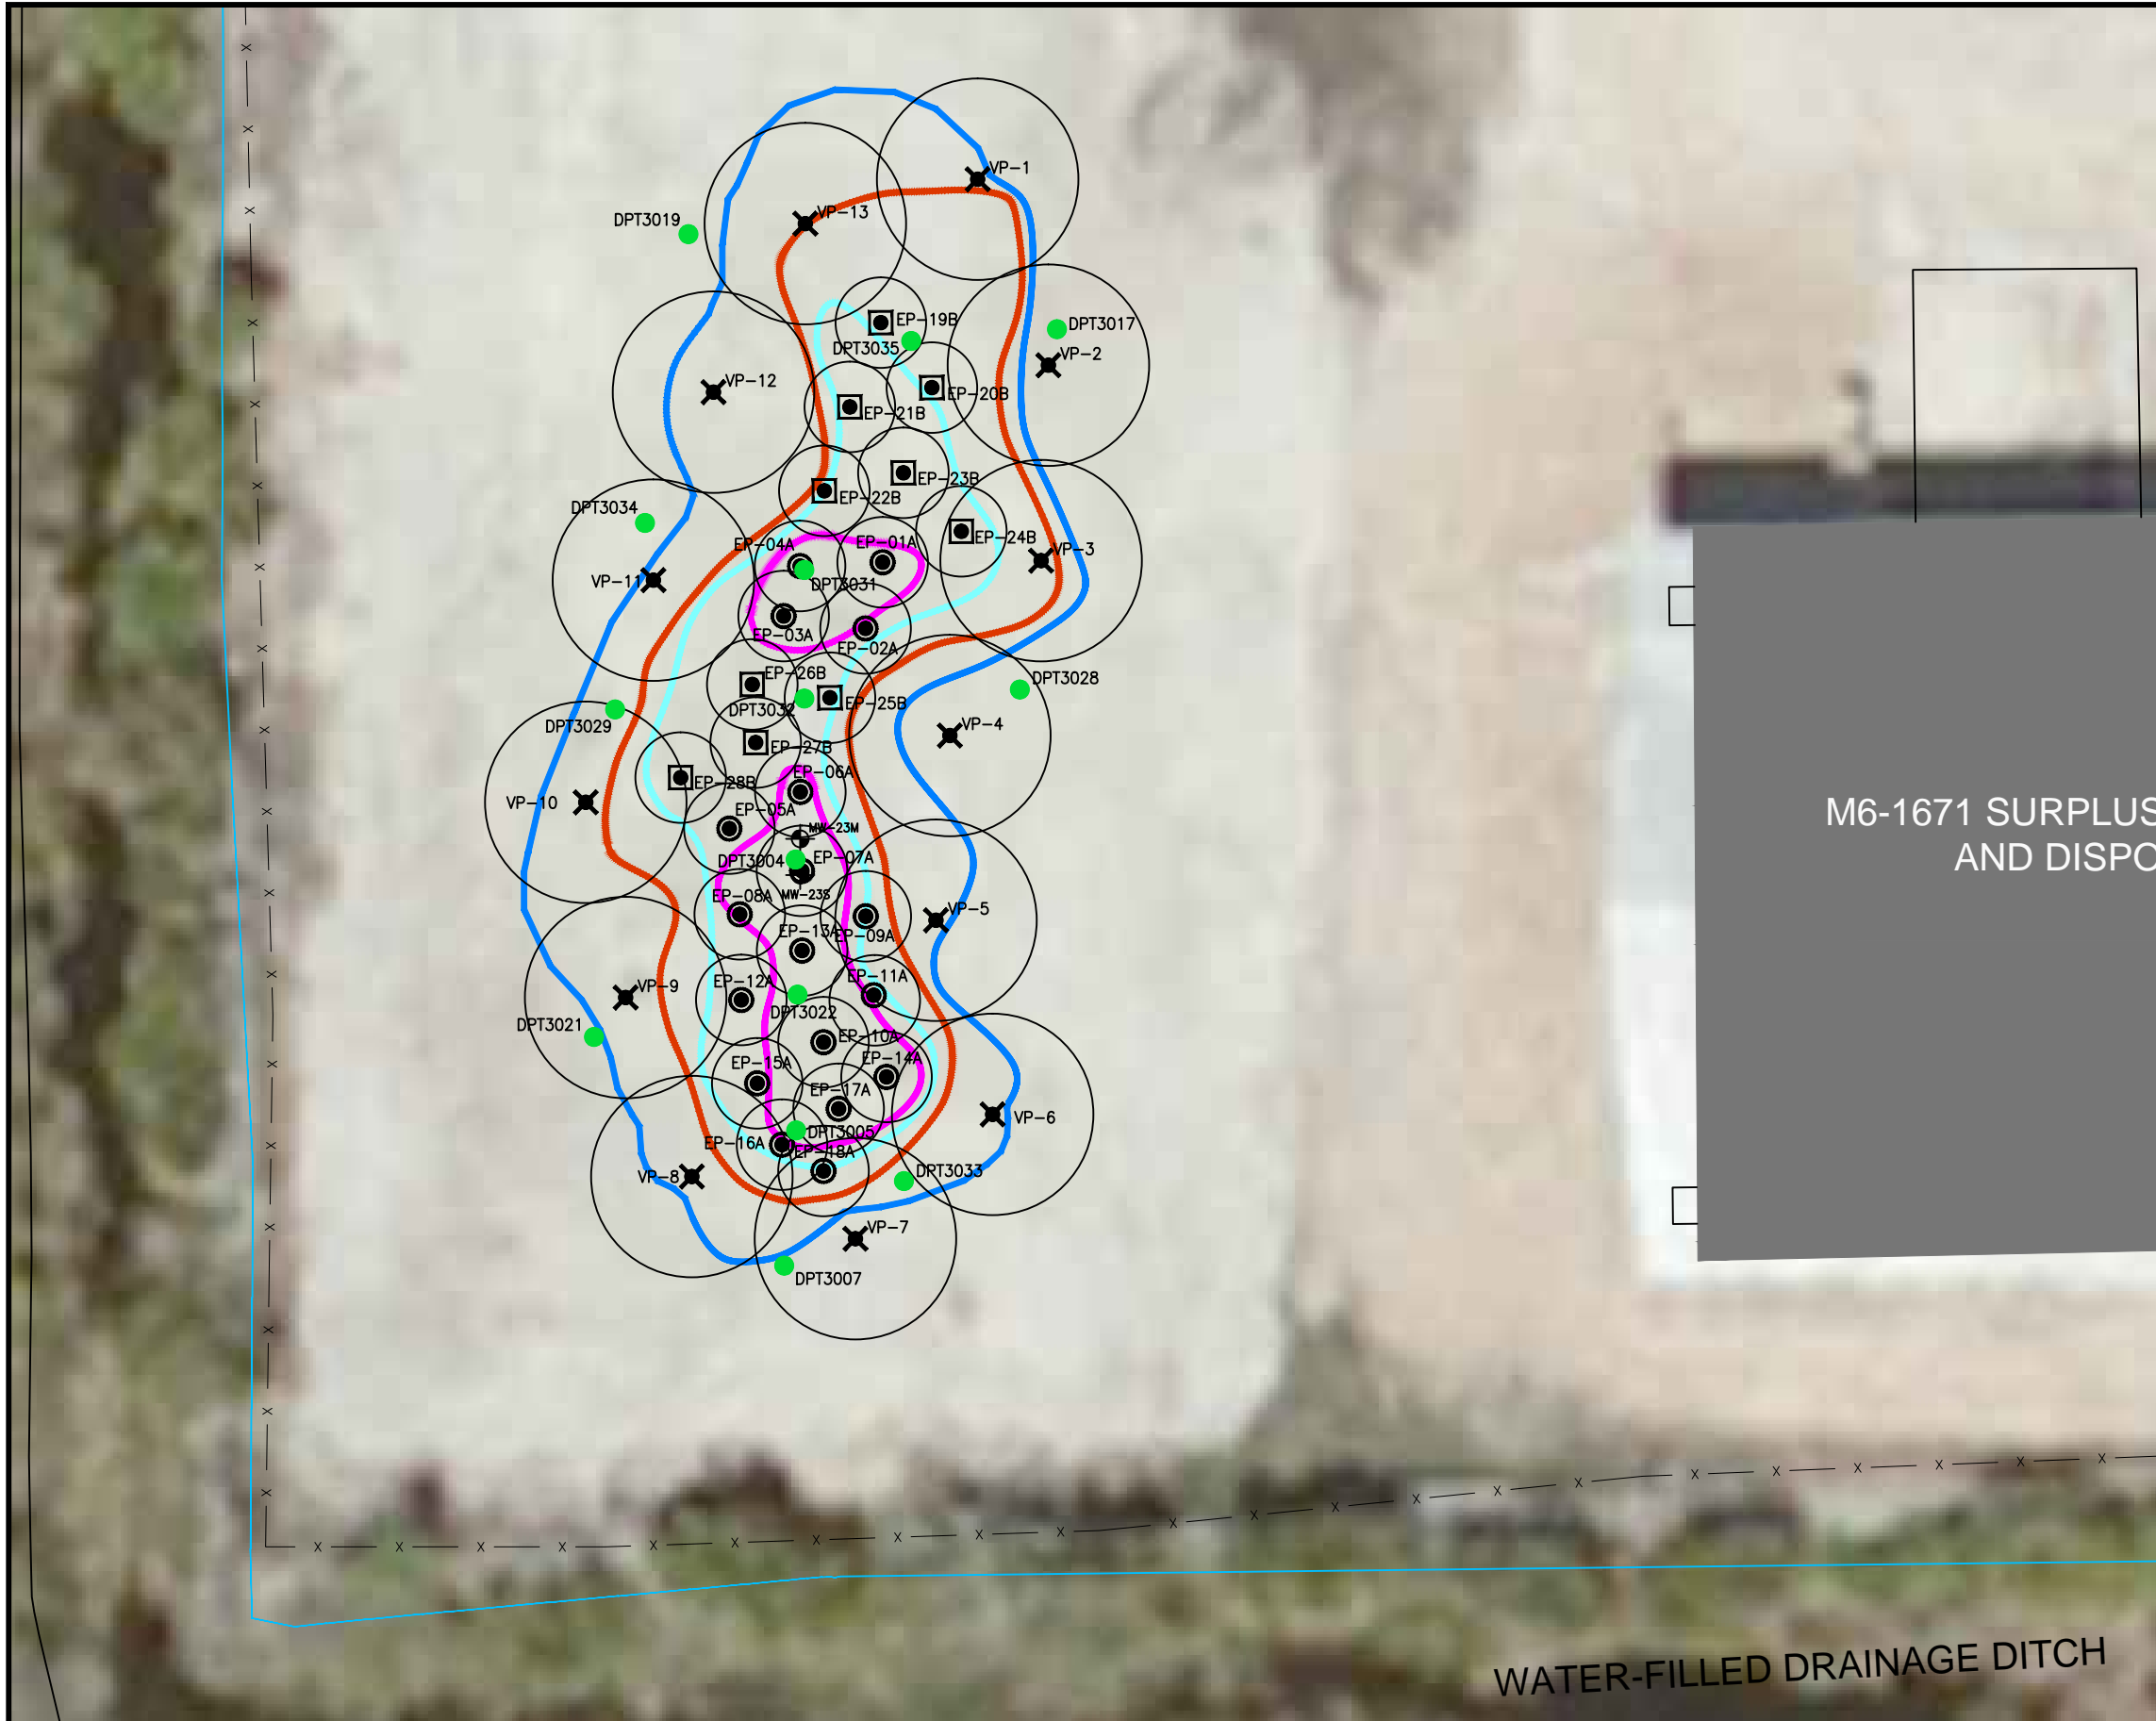
Figure 1-3

**GSA Reclamation Yard  
Southwest Hot Spot Interim Measure  
Injection Points and Performance Monitoring Sample Locations**

A total of 9,060 gallons of EZVI was injected at 28 locations, with an expected radius of influence (ROI) of 6 ft. based on prior results in similar formations, as shown on Figure 1-3. However, the EZVI points were laid out on 5 ft. centers to be conservative. VO/L solution (26,000 gallons) was injected at 13 locations encircling the EZVI treatment area (Figure 3). The VO/L points were on 12 ft. centers, with solution injected between 12 and 27 ft. bgs. The total area treated with EZVI and VO/L was approximately 0.12 acres (5,200 square feet), with varying intervals treated between 11 to 27 ft. bgs. A detailed description of the treatment activities can be found in the Implementation Report (Jacobs-CORE, 2014).

Direct push technology (DPT) sample locations are shown in Figure 3, along with injection points and the presumed radius of influence for the injected materials. Field forms are attached in Appendix B.

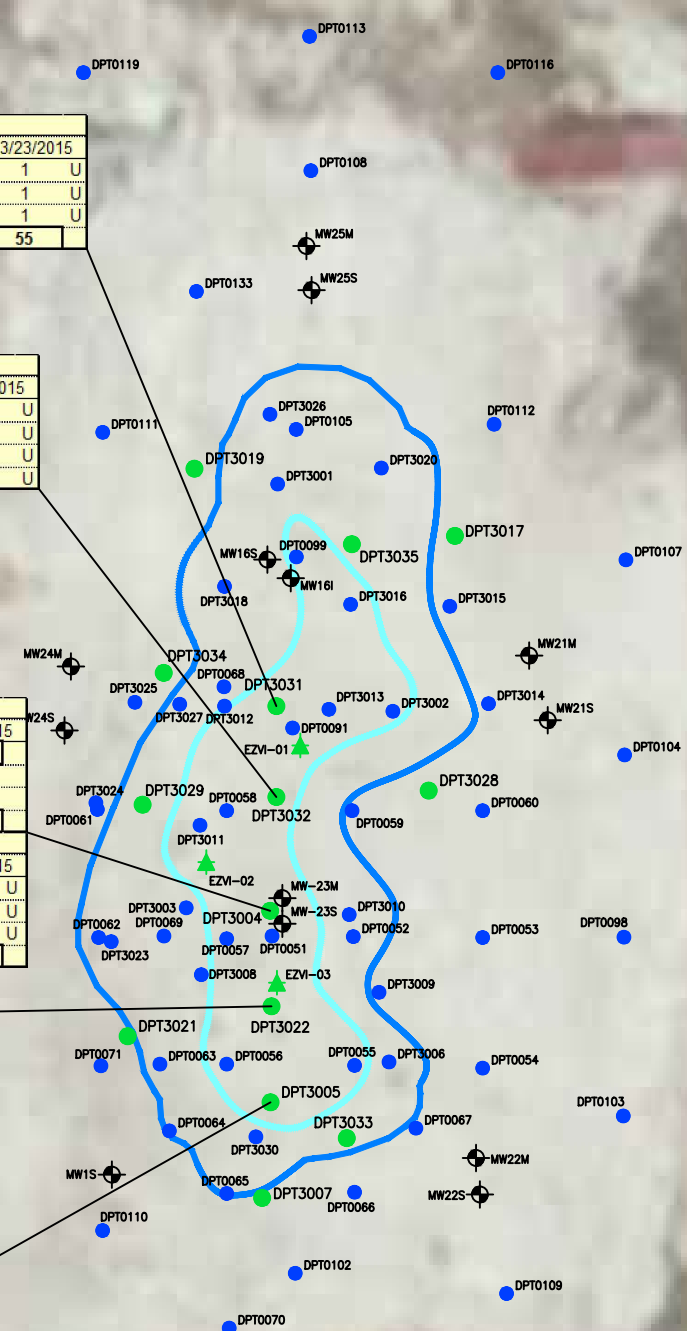
Figure 3-2

GSA Reclamation Yard  
Southwest Hot Spot Interim Measure  
Performance Monitoring Results, EZVI Treatment Area

EZVI was applied to the portion of the Southwest Hot Spot where PCE concentrations were 10,000 µg/L or higher. Five DPT performance sampling locations are within that area; from north to south: DPT3031, DPT3032, DPT3004, DPT3022 and DPT3005 (Figure 3-2). In the four northerly locations, PCE and TCE levels have decreased by 1 to 2 orders of magnitude at all intervals. At the southernmost point, DPT3005, where product was observed during baseline sampling, PCE decreased by 1 order of magnitude in the 19-23 and 27-31 ft. bgs intervals, and by 2 orders of magnitude in the 15-19 ft. bgs interval. In the 23-27 ft. bgs interval, PCE concentrations increased by an order of magnitude between December 2012 and March 2015. The levels of TCE declined in the 15-19 ft. bgs interval, and increased in the 19-23 and 23-27 ft. bgs intervals.

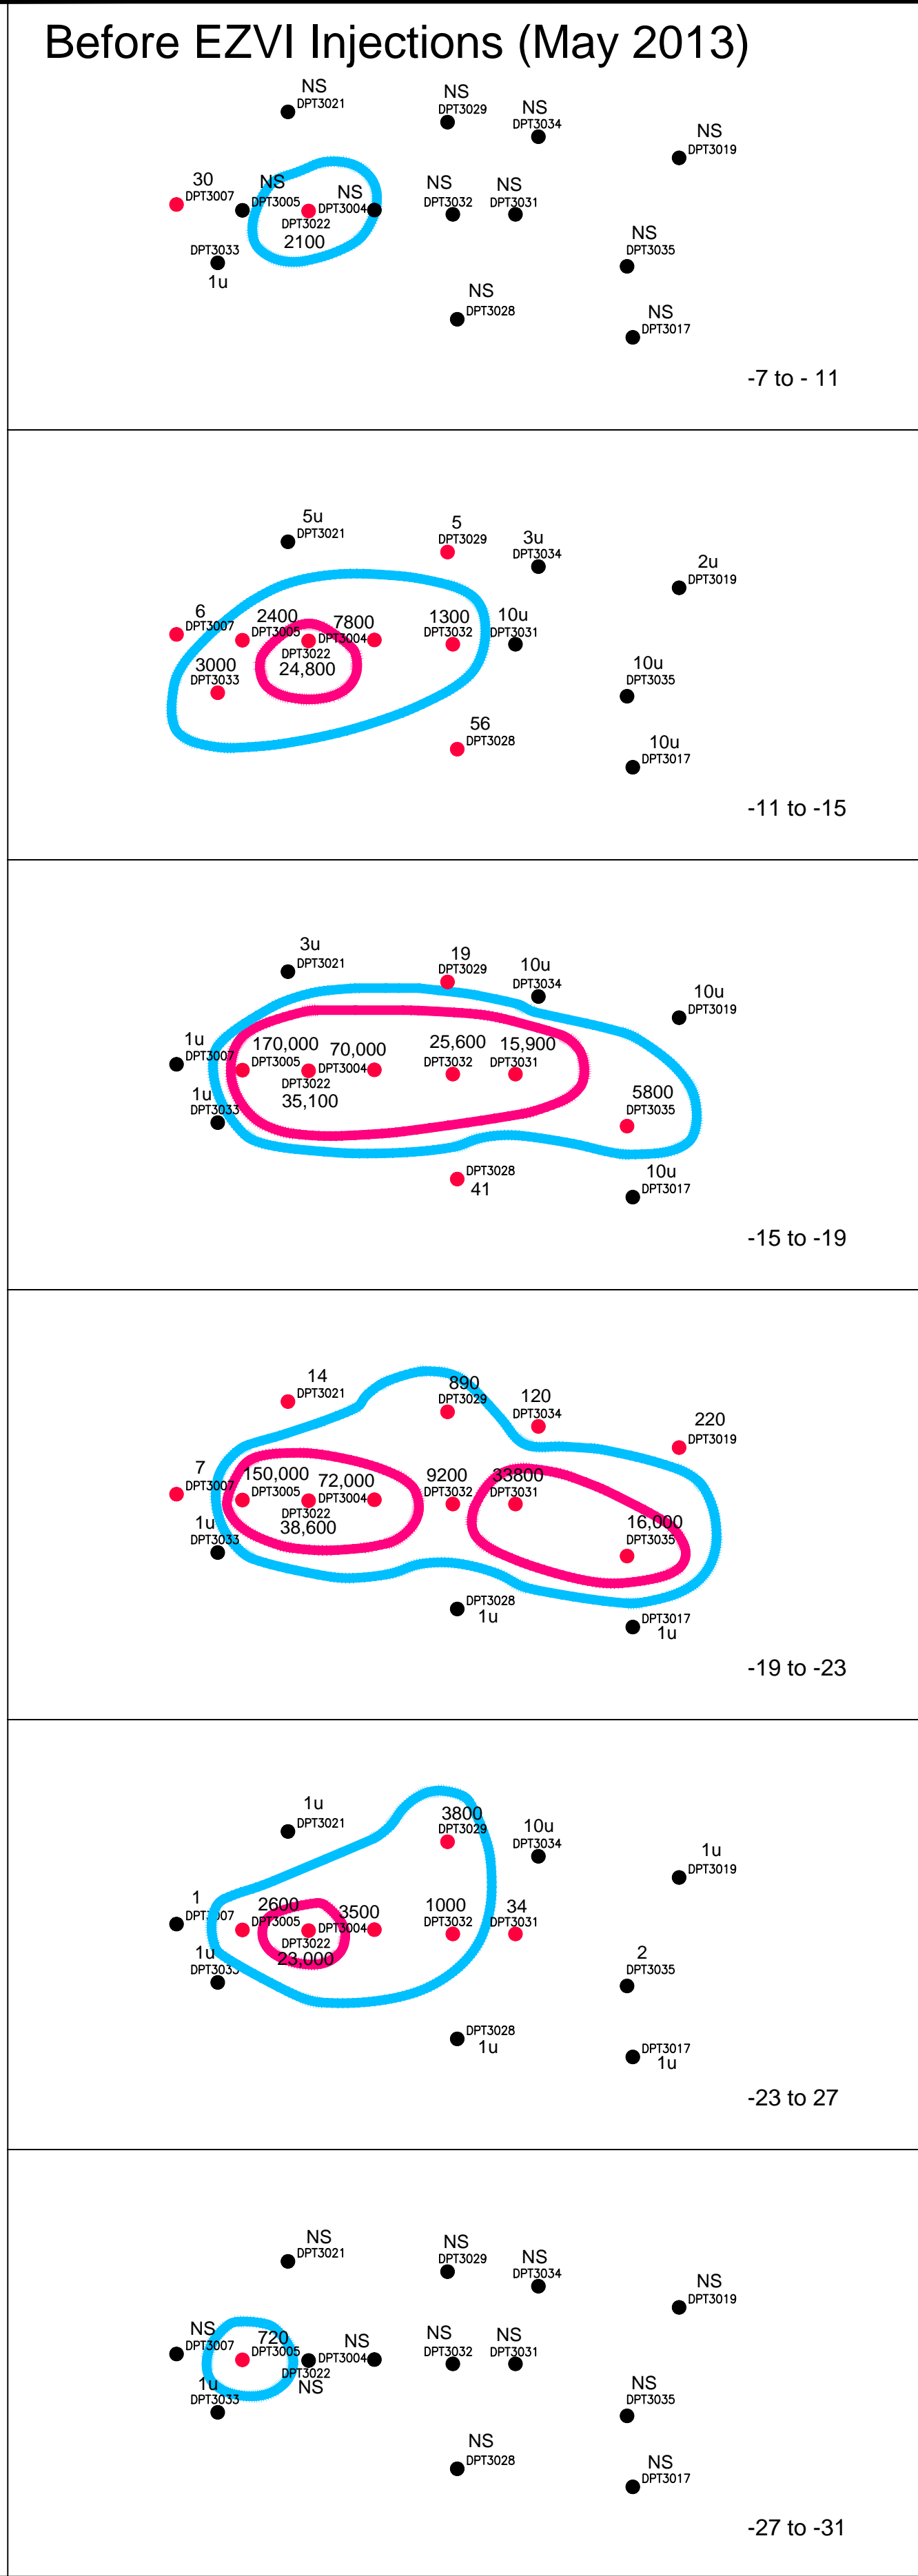
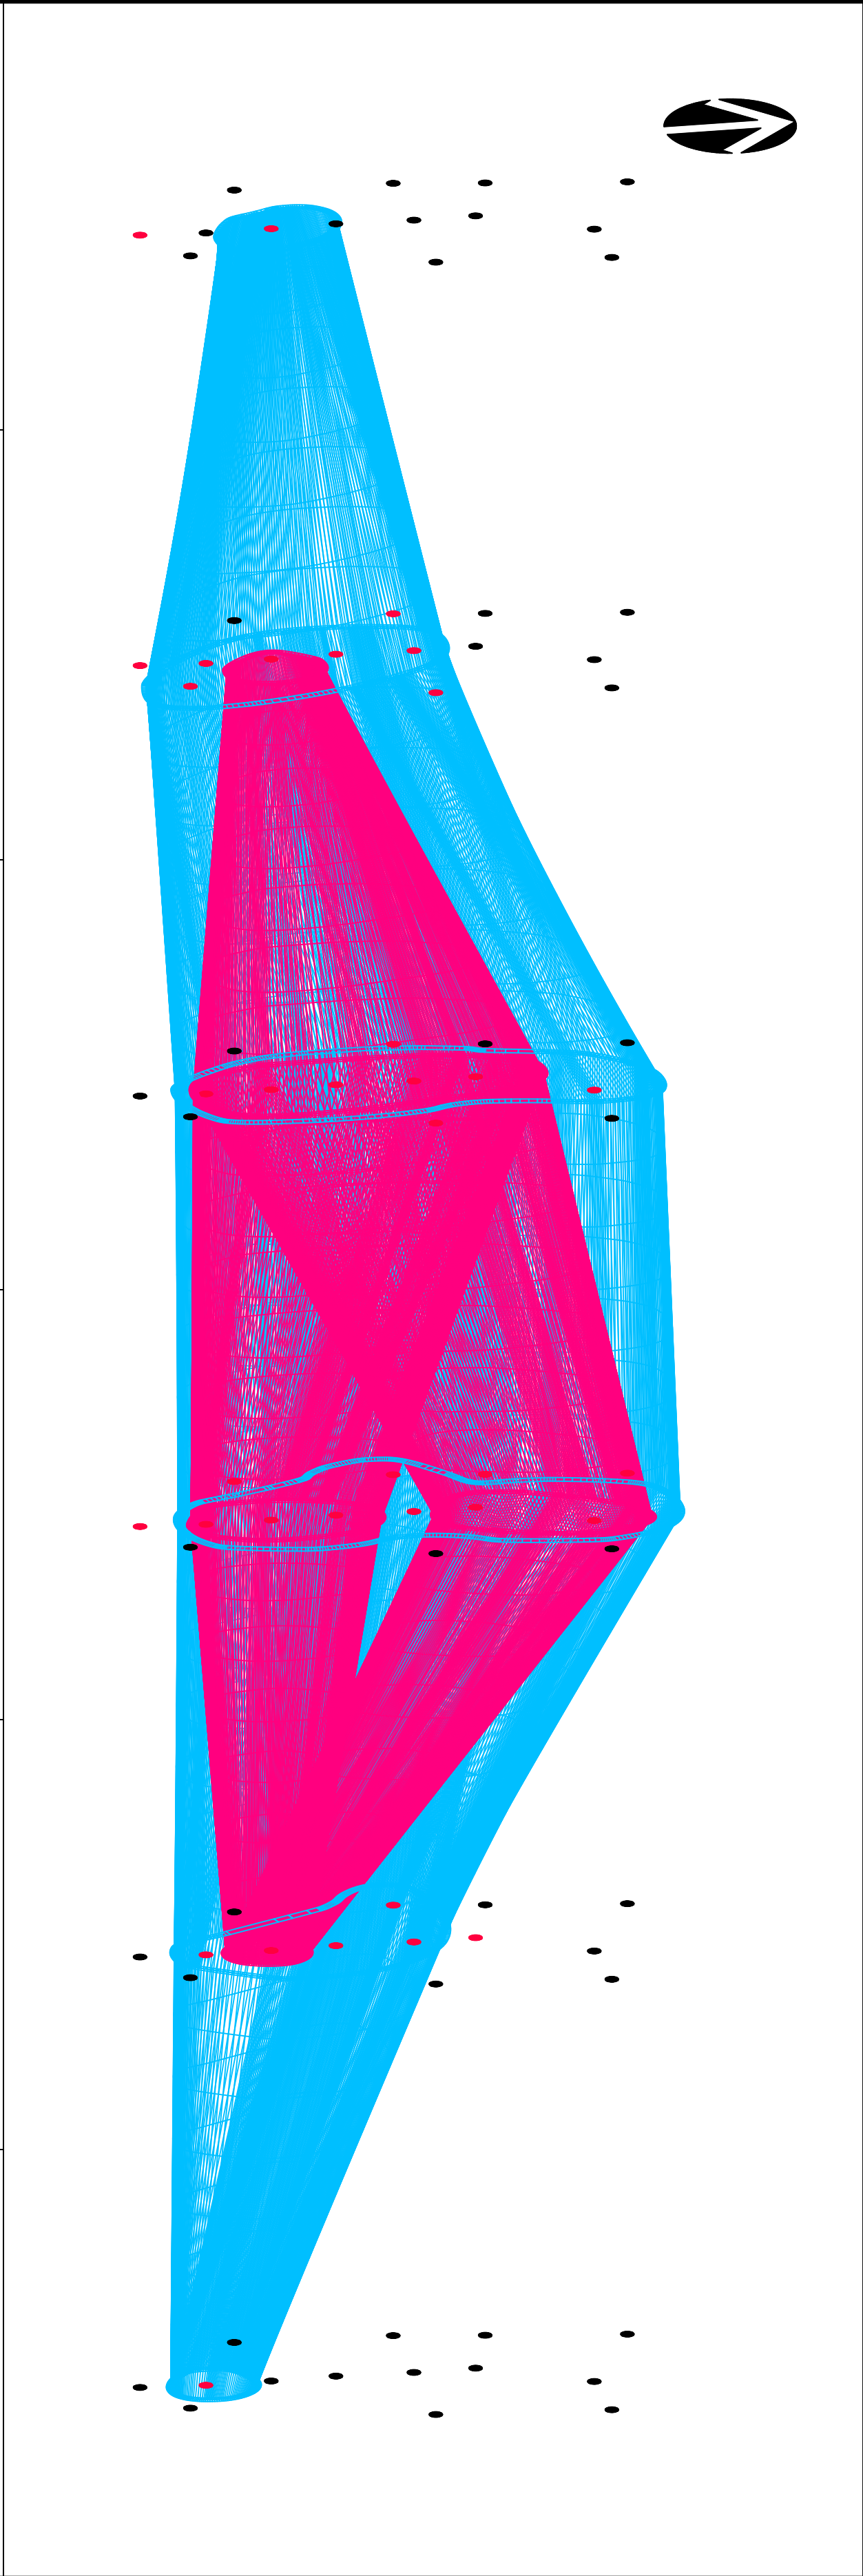
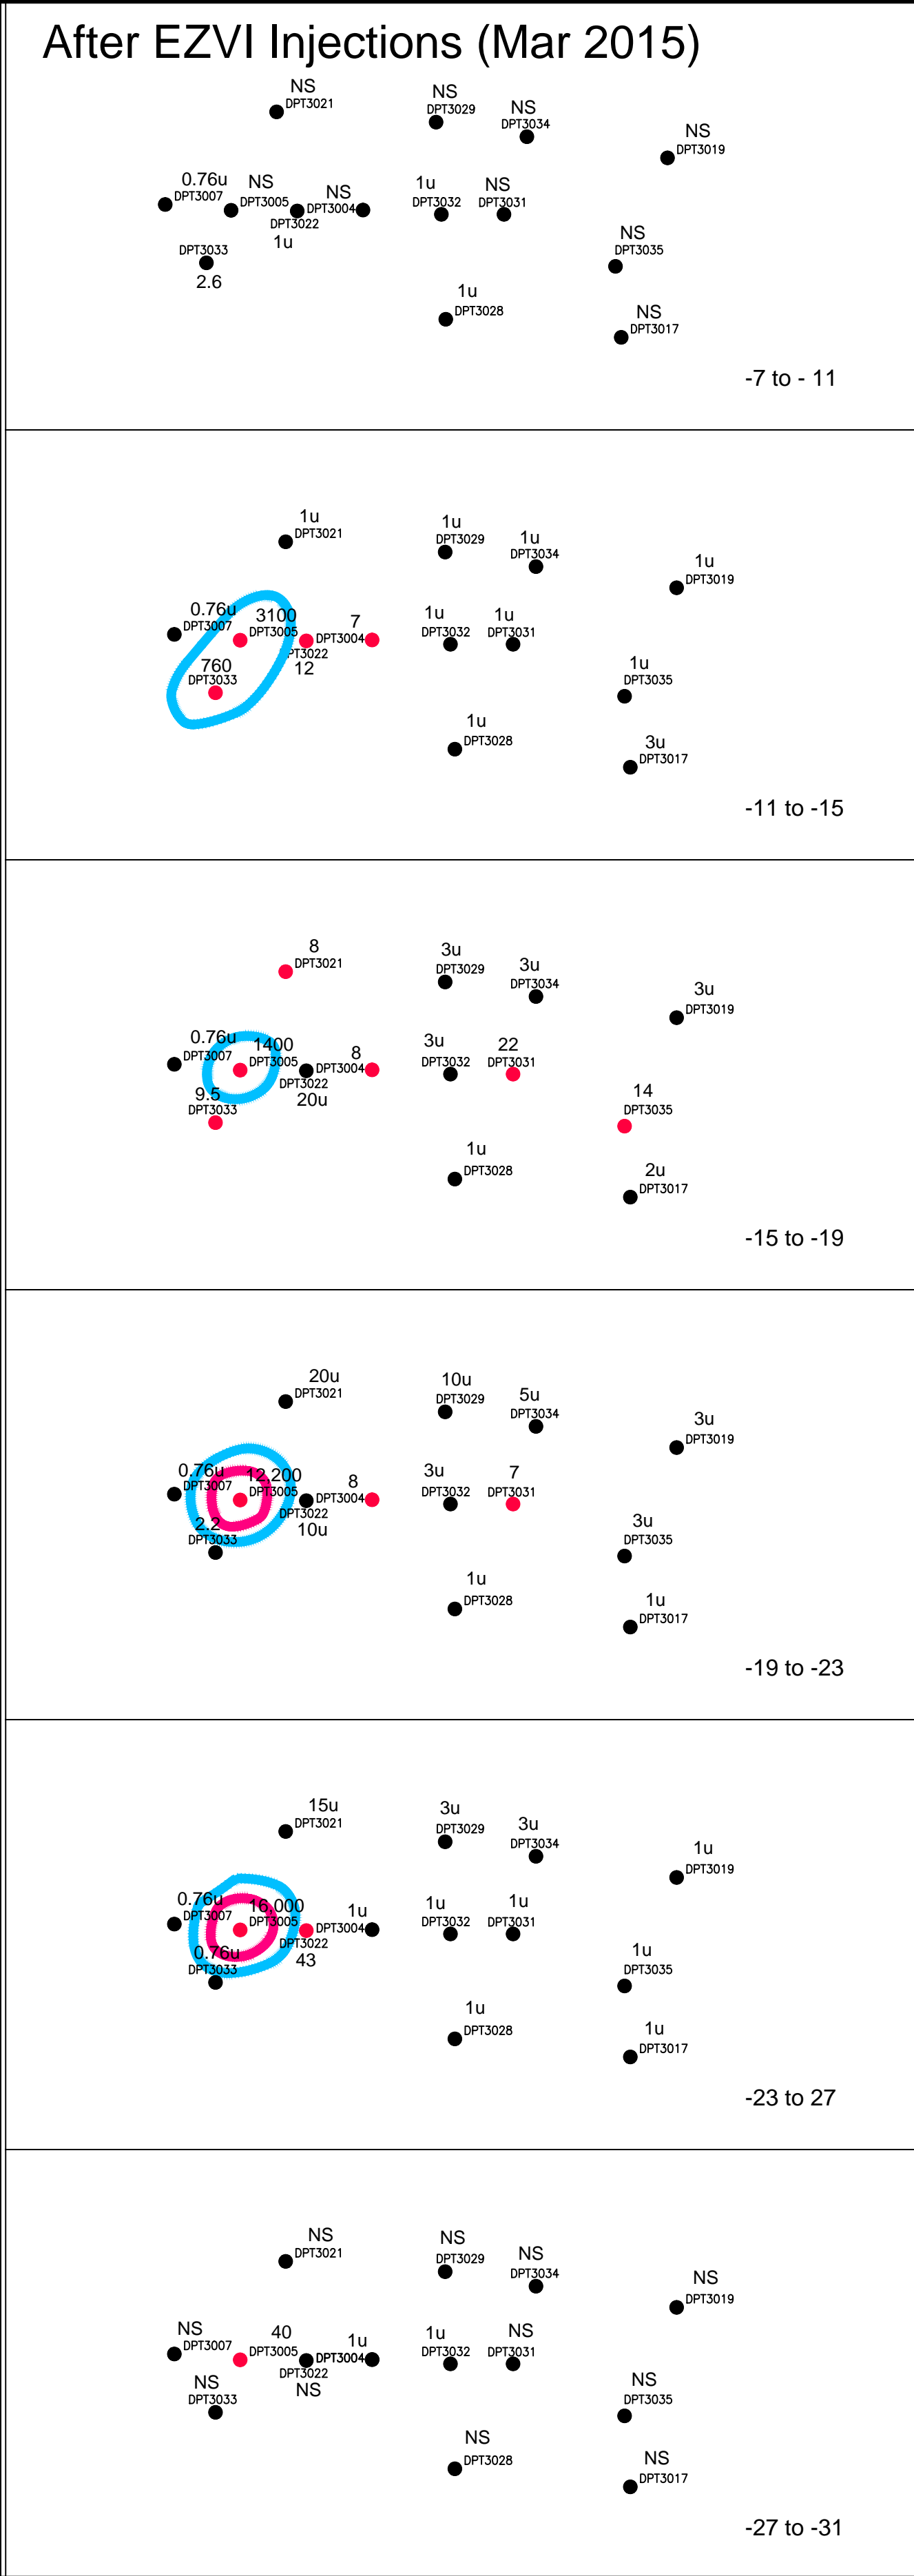
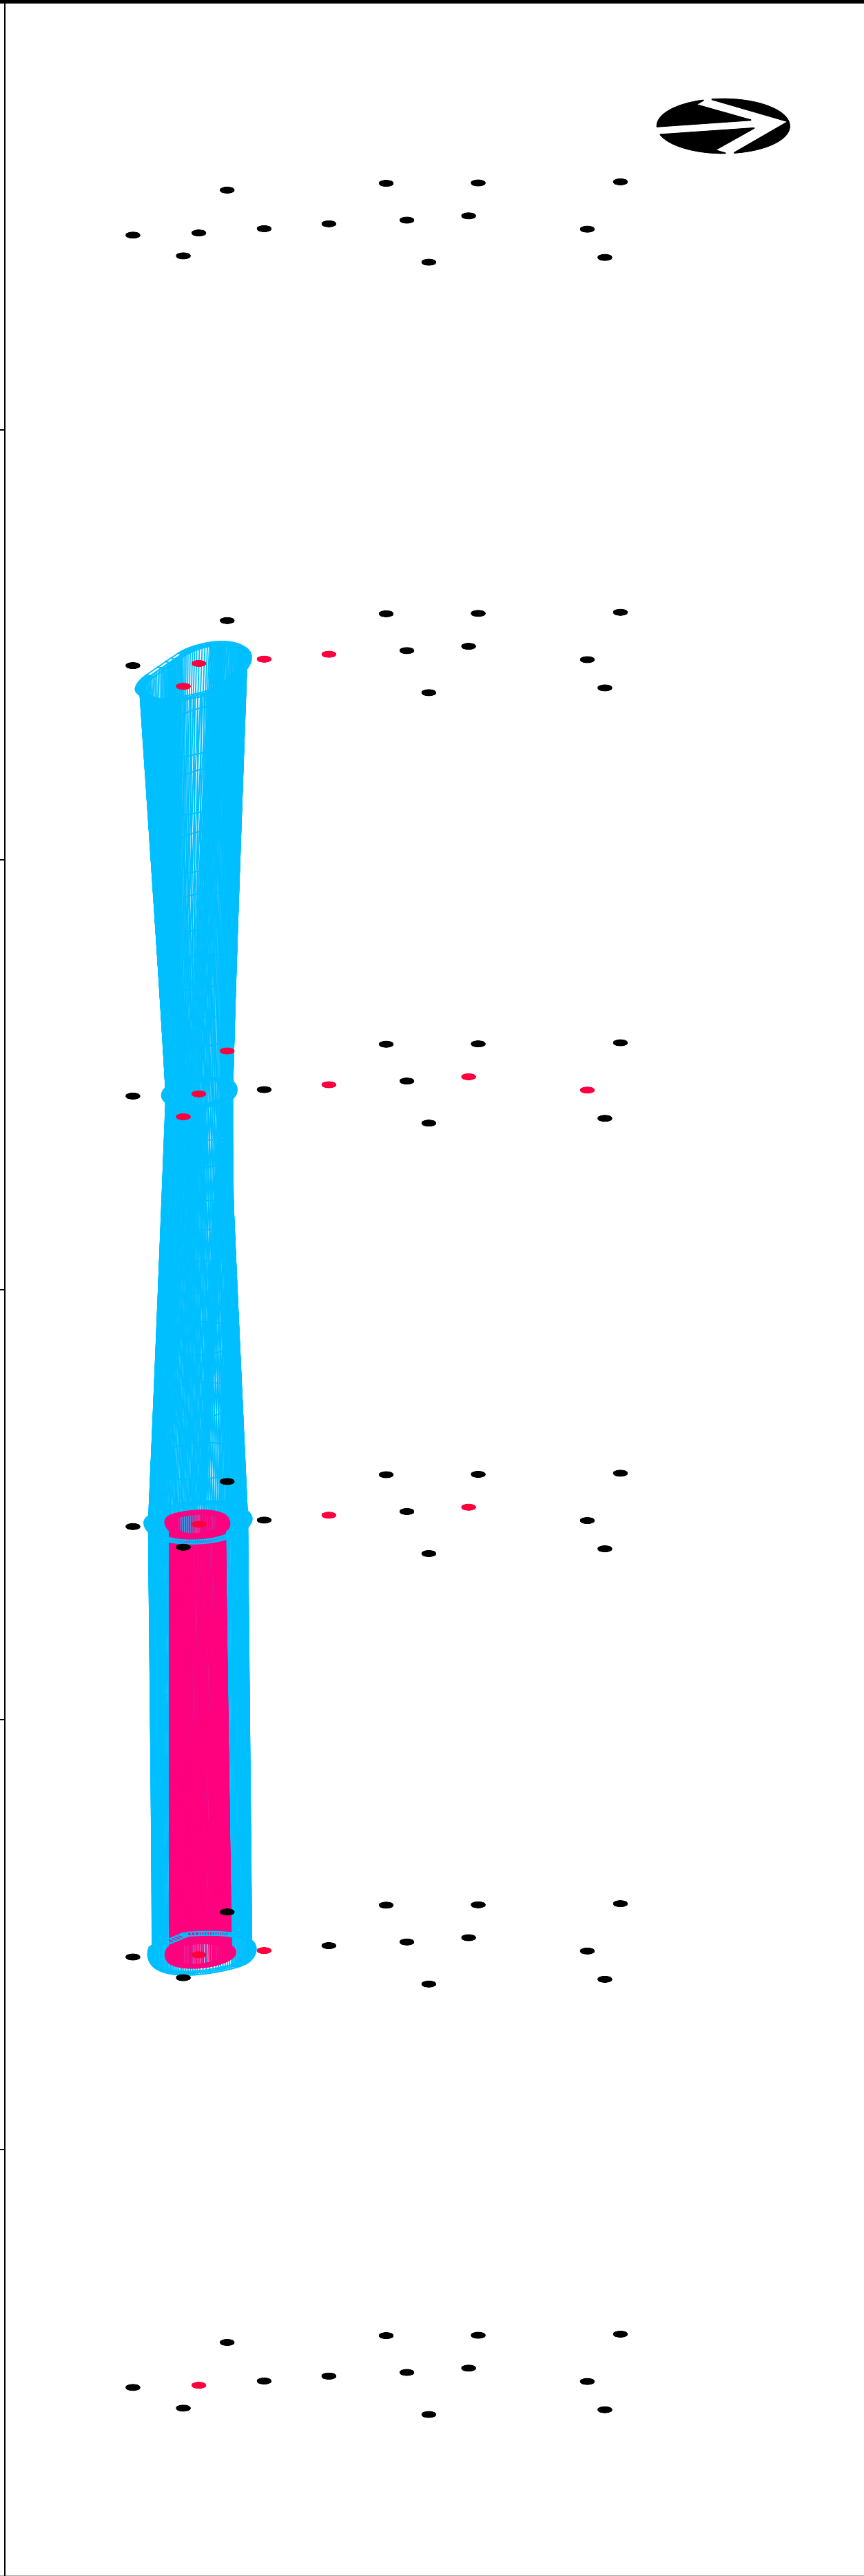
**PCE inferred Volume Comparison**  
Note:  
Z axis is exaggerated on drawing for presentation purposes.

Depths in feet	Before EZVI		After EZVI		Reduction
PCE 300ppm	sf	cf	sf	cf	
-7 to -11	490	1960	0	0	
-11 to -15	2075	8300	490	1960	
-15 to -19	3285	13140	180	720	
-19 to -23	3810	15240	380	1520	
-23 to -27	1970	7880	390	1560	
-27 to -31	270	1080	0	0	
Total cf		47600		5760	
				12.10%	87.90%
PCE 10,000ppm					
-7 to -11	0	0	0	0	
-11 to -15	290	1160	0	0	
-15 to -19	1880	7520	0	0	
-19 to -23	1640	6560	130	520	
-23 to -27	205	820	150	600	
-27 to -31	0	0	0	0	
Total cf		16060		1120	
				6.97%	93.03%

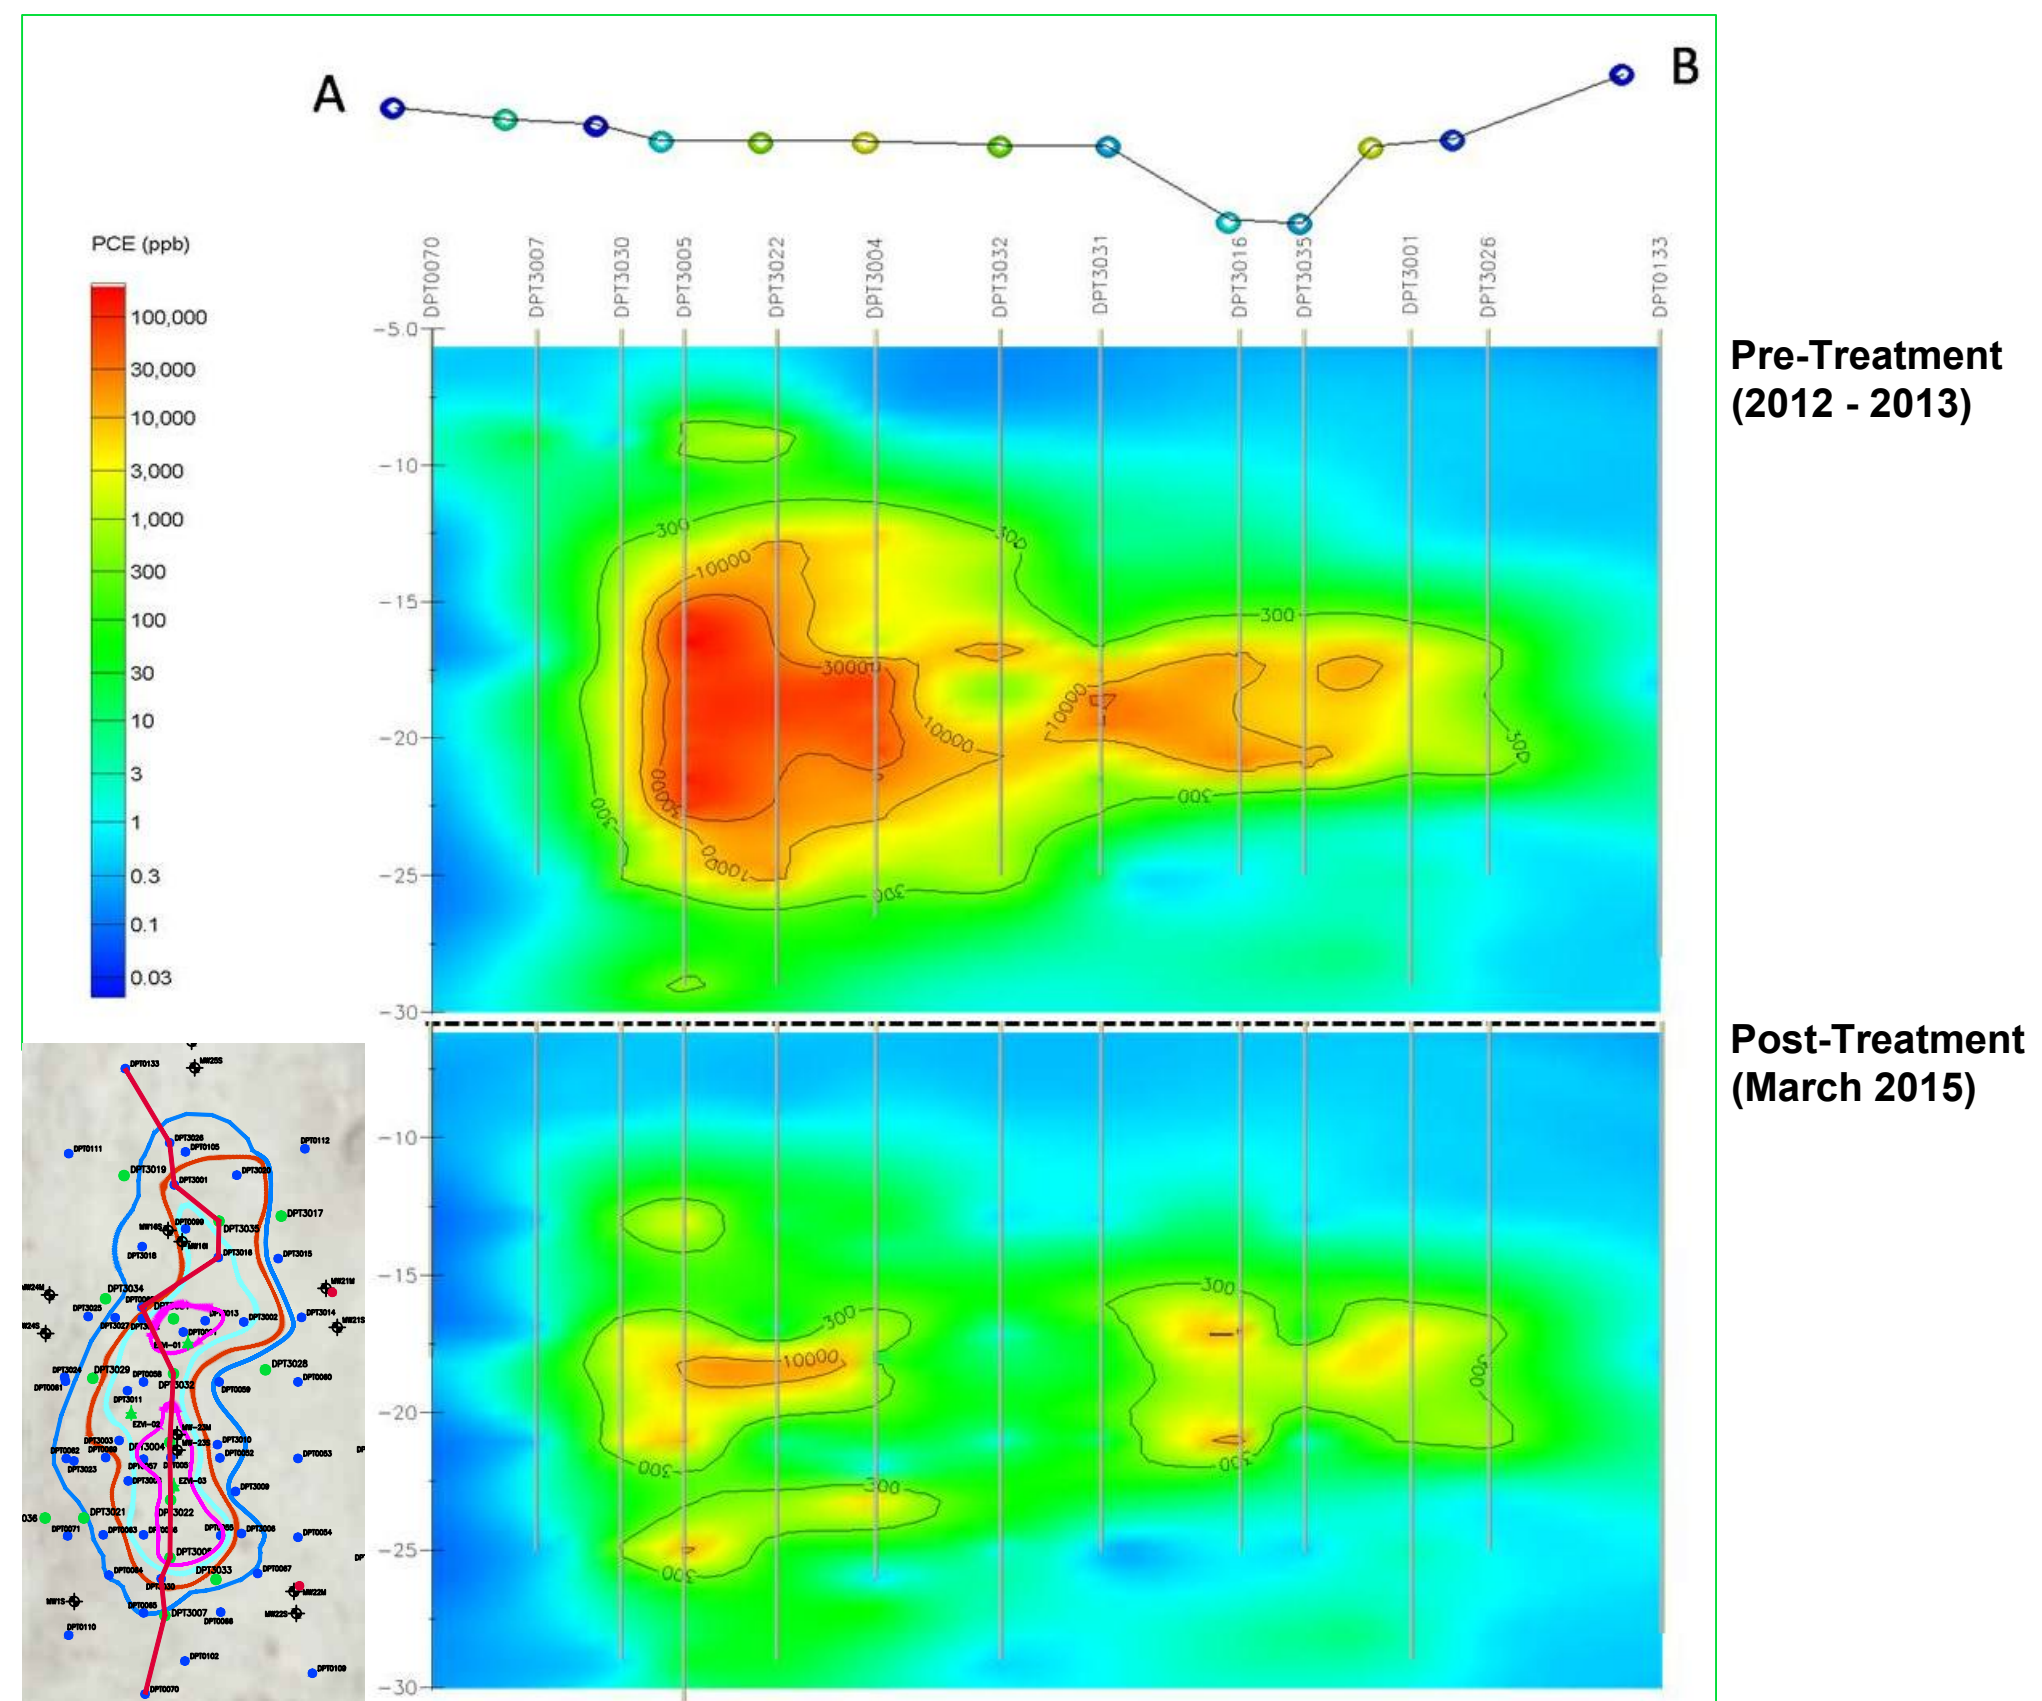
Figure 5-2a

**PCE Cross Section with 300, 10,000, 30,000 ppb Isopleths (Historical and PM Data)**

GSA Reclamation Yard  
Southwest Hot Spot Interim Measure  
Pre- and Post-Treatment PCE Cross-Section Using EVS
